ANALIZA UZROKA POJAVE OTKAZA SUS MOTORA I PREDLOG ZA NJEGOVO OTKLANJANJE

Na motoru Caterpillar USA tip 3126, sa brojem BEJ12686, radne zapremine 7200 cm³ i snage 168 kW (slika 1), koji je ugrađen u drobilicu za drvo proizvođača Vermeer Mfg. Company, tip BE 2000XL sa identifikacionom oznakom 1VRZ1S20171000278 (slika 2), došlo je do pojave otkaza. Usledio je pokušaj otklanjanja tog otkaza. Po završetku svih sprovedenih postupaka održavanja koji su imali za cilj vraćanje motora u ispravno stanje, došlo je vrlo brzo do ponovne pojave otkaza, i to na isti način.

ANALYSIS OF THE CAUSES OF IC ENGINE FAILURE AND PROPOSAL FOR ITS REMOVAL

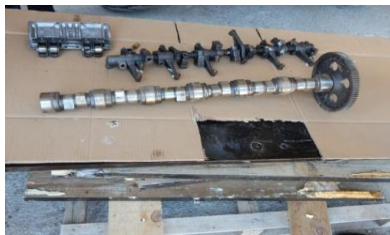
Slika 3. Bregasta osovina, osovina klackalica sa klackalicama i nosač rolnica motora Caterpillar tip 3126 -celokupan izgled
Figure 3. Camshaft, rocker arm with swingarms and Caterpillar 3126 engine roller bearing - overall layout

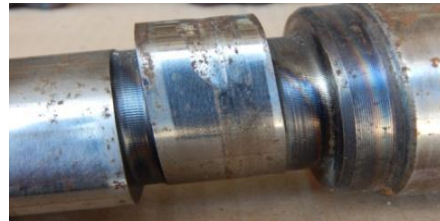
Slika 6. Bregasta osovina motora Caterpillar 3126- oštećenje brega šestog izduvnog ventila-pogled odozgo
Figure 6. Caterpillar 3126 Camshaft - Six Exhaust Valve Camshaft Damage - Top View

Veliko oštećenje brega izduvnog ventila šestog cilindra (slike: 5,6,7), ali i rolnice (slika 15) i njene osovinice (slika 16), upućuju na zaključak da drobilica za drvo, posle havarije, nije odmah isključena.

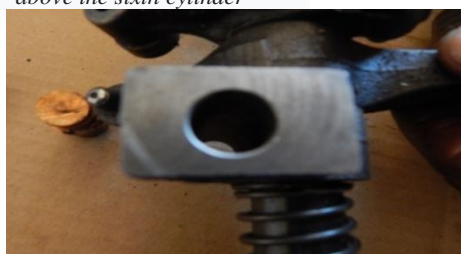
Slika 9. Oštećena treća površina nosača klackalica koja dodiruje glavu iznad šestog cilindra, motora proizvođače Caterpillar 3126

Figure 9. The damaged third surface of the rocker arm that touches the head above the sixth cylinder, Caterpillar 3126 engine

Usled povećanja zazora u sklopu klackalica izduvnog ventila šestog cilindra i osovine klackalica (slika 12), ali i usled nedovoljno zategnutih zavrtnjeva koji pritežu klizne ležajeve klackalice sa glavom motora (vidljive su velike neravnine usled habanja tih površina na slikama: 7,8,9,10) došlo je do većeg aksijalnog pokretanja - klačenja klackalice (što se nije smelo dozvoliti).

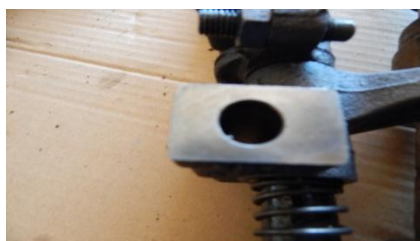
Slika 11. Neoštećena druga površinu nosača klackalica koja dodiruje glavu iznad šestog cilindra, motora Caterpillar 3126 - radi upoređenja sa oštećenom površinom

Figure 11. A intact second surface of the rocker arm that touches the head above the sixth cylinder, Caterpillar 3126 engine - for comparison with the damaged surface

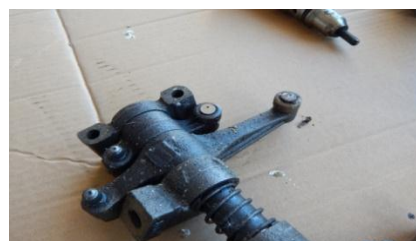
Slika 12. Klackalica koja dodiruje glavu iznad šestog cilindra motora drobilice za drvo - povećan zazor koji omogućuje i aksijalno pomeranje i klaćenje klackalice šestog izduvnog ventila

Figure 12. The rocker arm that touches the head above the sixth cylinder of the wood crusher - enlarged clearance allowing both axial movement and rocking of the rocker of the sixth exhaust valve

U zaključku ovog rada može se navesti da odgovornost za nastalu havariju motora "Caterpillar" USA tip 3126, broj motora BEJ12686, koji je ugrađen u drobilicu za drvo proizvođača "Vermeer Mfg. Company" tip BE 2000XL, sa identifikacionom oznakom 1VRZ1S20171000278, treba pripisati serviseru koji nije utvrdio uzrok pojave prve neispravnosti na motoru, a samim tim nije ni sproveo potrebne postupke održavanja motora (prvenstveno podešavanje razvodnog mehanizma motora).

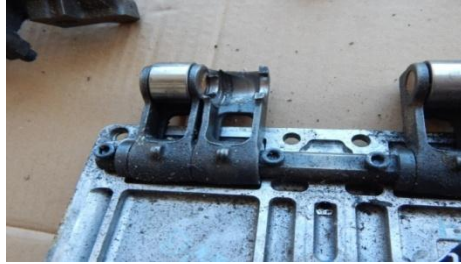
Slika 13. Oštećeno ležište rolnice koja usmerava kretanje šipke podizača šestog izduvnog ventila motora
Figure 13. A damaged roll bearing that directs the choke of the sixth exhaust valve of the engine

Usled krivljenja šipke podizača izduvnog ventila šestog cilindra došlo je do pucanja kliznog ležišta osovinice na kojoj se nalazi rolnica koja ima zadatak "vođenja" ove šipke (slike: 17).

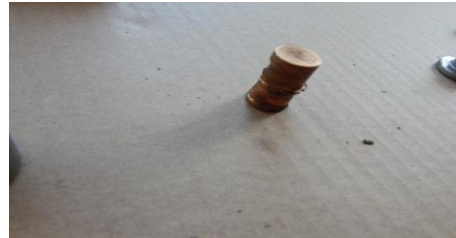
Slika 16. Oštećena osovinica rolnice koja usmerava kretanje šipke podizača šestog izduvnog ventila motora drobilice za drvo
Figure 16. A damaged roll axis that directs the chalk rod lift of the sixth exhaust crusher engine of a wood shredder

Posle pucanja kliznog ležišta osovinice na kojoj se nalazi rolnica koja ima zadatak "vođenja" šipka podizača izduvnog ventila šestog cilindra, došlo je do ispadanja osovinice rolnice (slika 16) iz ležišta, i same rolnice (slika 15) sa osovinice i do njihovog upadanja u prostor između bloka motora i brega izduvnog ventila šestog cilindra što je dovelo do velikog oštećenja ovog brega (slike: 5,6,7), jer je motor i dalje radio (tada sa pet cilindara), a bregasto vratilo se okretalo sve do konačnog isključivanja mašine jer se ono okreće - pogoni preko svog zupčanika (slike: 5) koji nije oštećen.

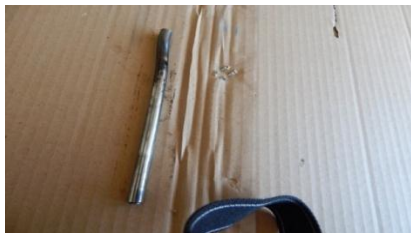
Slika 17. Oštećeno – polomljeno stablo (obostrano) izduvnog ventila na šestom cilindru pogonskog motora
Figure 17. Damage view - broken on both sides of the exhaust valve tree on the sixth cylinder of the drive engine

Usled pucanja zadnjeg dela izduvnog ventila na šestom cilindru zajedno sa svojim osiguračem, šipka podizača izduvnog ventila šestog cilindra nije bila u stanju da da podiže zadnji kraj klackalice ovog ventila jer je došlo do pojave velikih otpora njegovom kretanju, te je zbog toga došlo do njenog krivljenja (slika 17).

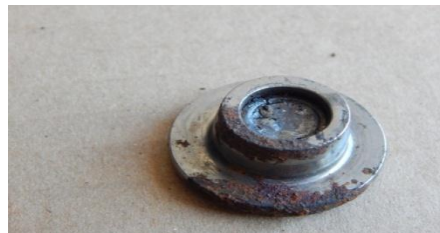
Slika 18. Oštećen - polomljen deo stabla izduvnog ventila na šestom cilindru sa svojim osiguračem u svom repnom delu pogonskog motora
Figure 18. A damaged - broken part of the exhaust valve tree on the sixth cylinder with its fuse in its tail section of the drive engine

To aksijalno kretanje klackalice, uz rotaciono kretanje (koje je jedino dozvoljeno u ovom sklopu) dovelo je do pucanja zadnjeg dela izduvnog ventila na šestom cilindru zajedno sa svojim osiguračem (slika 18).

Pošto se izduvni ventil nije zaglavio (kao kad se dogodila prvi put havarija na ovom motoru), on je krenuo prema klipom i u direktnom kontaktu sa klipom polomljena je njegova pećurka (slike 14,18,19), što pri normalnom radu motora nikada do toga ne bi moglo da dođe. Pri tom je došlo i do loma sedišta ovog ventila (slika 14).

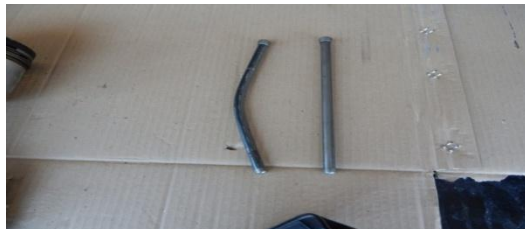
Slika 19. Deformisana i nedeformisana šipka podizača izduvnog ventila na šestom cilindru motora

Figure 19. Deformed exhaust valve pickup rod on engine sixth cylinder next to undeformed

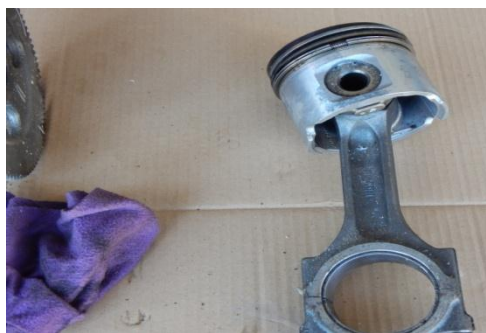
Slika 21. Klip i klipnjača šestog cilindra motora drobilice za drvo

Figure 21. Piston and piston rod of a six-cylinder wood shredder engine

- Da je glava motora bila oštećena (naprsila) na čelo klipa bi dospela tečnost za hlađenje, tako da bi čelo klipa imalo sasvim drugu boju-plavičastu, a došlo bi i do njegovog nagorevanja, kao i nagorevanja cilindra motora. U konkretnom slučaju do toga nije došlo (slika 21) jer čelo klipa ima čistu-fabričku boju, a na cilindru nema nikakvih termičkih promena.

Prethodni opis upućuje na zaključak da nije bilo neophodno sprovesti tzv. hidro-test glave motora, i da glava motora nije doprinela da dođe do havarije motora.

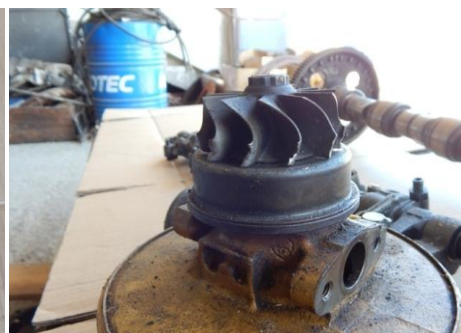
Slika 22. Oštećene lopatice turbine motora drobilice za drvo

Figure 22. Damaged wood shredder turbine engine blades

Polomljeni delići sedišta ventila i pećurke ventila uleteli su u prostor turbine i izazvali njeno oštećenje (slika 22).

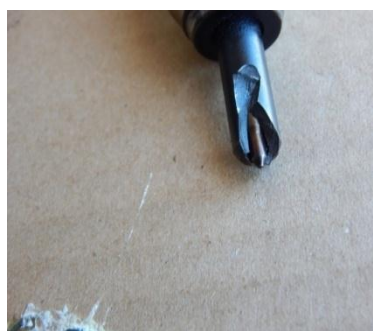
Slika 24. Oštećen brizgač - injektor šestog cilindra motora drobilice za drvo

Figure 24. Damaged Injector - Six Cylinder Engine Injector for Wood Crusher

Polomljeni delovi pećurke izduvnog ventila šestog cilindra, kao i delovi sedišta ovog ventila, izazvali su oštećenje vrha injektora-brizgača (slika 22,23), ali i čela klipa šestog cilindra (slika 14) i skoro neprimetno oštećenje cilindra u gornjem delu što ne utiče na dalju upotrebnu vrednost šestog cilindra.
