EVALUATION OF THE CAUSES OF EROSION AND SOLUTION: CASE STUDY UMUOKORO LOWA, IHITTE/UBOMA LOCAL GOVERNMENT AREA, IMO STATE

Abstract: Erosion is a condition in which the surface of the earth declines gradually due to wearing away by the action of water, wind and human activities. This research was carried out to determine the types of erosion occurring in this area and provide proper erosion management techniques that will help to control the erosions occurring in this area. Erosion control techniques are used to prevent and reduce soil erosion. Visual examination, interviews from residents and measurement of measurement of the erosion to know the cause, nature and type of erosion at the sites were carried out. Results of visual examination and interviews revealed that the erosion was caused by abandoned road construction and poor land management practices of the residents. Measurements from site A, D and G at the month of May which were 0.28, 0.29 and 0.29 m in depth respectively showed that they have already degenerated from splash to rill and is gradually forming gully, while site B and C at the month of May which were 1.53 and 2.34 m in depth respectively were still active gulli

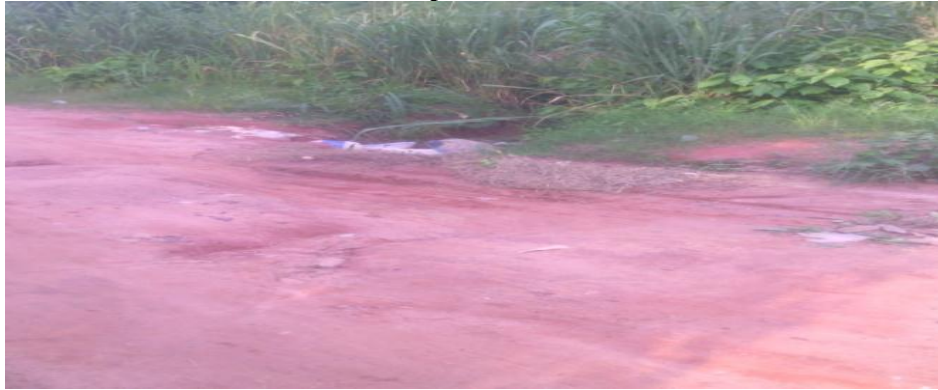
Plate 1: Erosion at site A

Table 1: Observation at site A

Month	Length (m)		Width (m)		Depth(m)		Nature
	X	Y	X	Y	X	Y	
March	9.3	9.8	0.99	1.14	0.14	0.17	Rill
April	9.8	10.2	1.14	1.24	0.17	0.23	Rill
May	10.4	11.1	1.27	1.35	0.23	0.28	Rill

The road was only graded and was not tarred, a graded road is prone to erosion because it is similar to a bare ground that does not have cover it should be tarred hence, the road graduated from splash to sheet then to rill. If care is not taken it will graduate to gully erosion. From the report gotten from the residents, it was observed that this site was not too bad until the time it was graded for construction.

The road should be re-awarded for finishing work and it should be completed by grading the road and ensure that is tarred and it must be reconstructed with side drains both at the left and right sides of the road. The work of the side drains is to transport water during rainfall from the road to the bushes. In addition mitre drain should be constructed with the side drain because sometimes the rainfall intensity and long duration of rain will make the side drains to be overflowed. Therefore, mitre drain is constructed along the side drain at 20 to 25 meter range. The work of the mitre drain is to divert excess runoff into the bush and prevent the road from been damaged by flood.

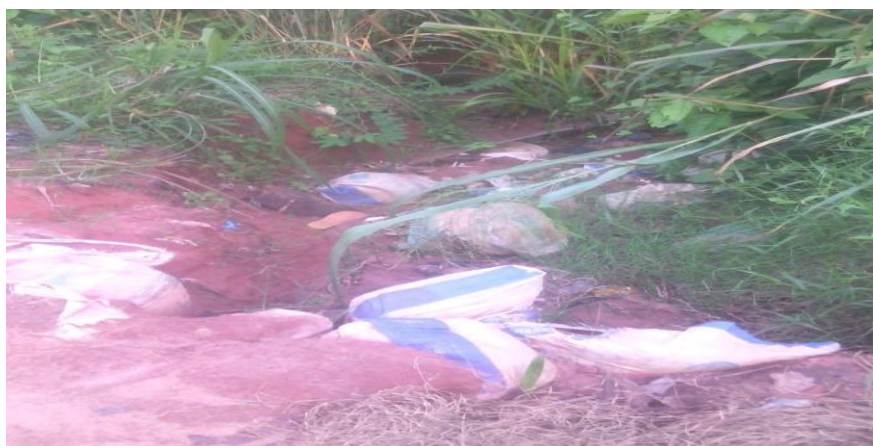
Plate 2: Erosion at site B

Table 2: Observation at site B

Month	Length (m)		Width (m)		Depth (m)		Nature
	X	Y	X	Y	X	Y	
March	13.37	13.45	0.98	1.12	0.94	0.99	Gully
April	13.45	13.56	1.12	1.20	0.99	1.3	Gully
May	14.06	15.00	1.26	1.32	1.39	1.53	Gully

From plate 2, it can be observed that the rate of runoff in this area is very high as it has already carried away the sand bags used in checking it. The water coming into the gully from different runoff sources has high erosive effect on the soil, because the interceptor ditches used in intercepting them were removed in the cause of abandoned road construction. From residents' point of view, it was observed that erosion in this site was aggravated due to human activities like soil excavation and improper refuse disposal thereby blocking the runoff channel. It was also observed that the removal of the interception channels also led to the increase in runoff passing through the area.

The runoff sources should be traced first and vegetative covers like grasses should be planted within the runoff sources to reduce the velocity of water flowing into the gully site. It can also be controlled by building a silt fence with gravel bags which will trap sediments that will fill the gully and allow easy passage of water through the pores of the bag. Reconstruction of interceptor ditches should be properly done so that runoff will be intercepted and prevented from coming down to this site.

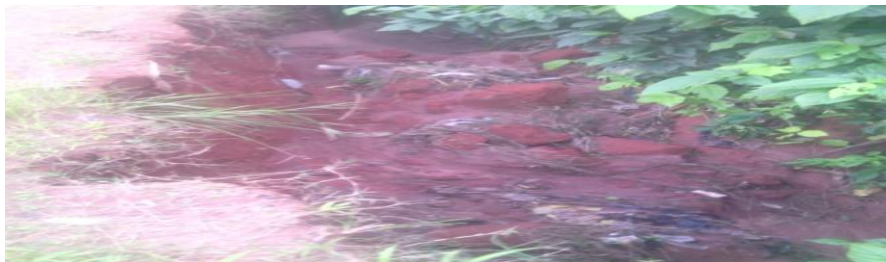
Plate 3: Erosion at site C

Table3: Observation at site C

Month	Length (m)		Width (m)		Depth (m)		Nature (m)
	X	Y	X	Y	X	Y	
March	8.6	9.0	3.0	3.29	1.7	2.0	Gully
April	9.0	9.4	3.29	3.4	2.0	2.17	Gully
May	9.46	10.7	3.45	4.0	2.26	2.34	Gully

From the plate 3 and response gotten the residents, it was observed that the gully occurring in this area is still very active. This site is a natural runoff channel but has been destroyed and exposed to erosion due to constant sand excavation that goes on there at the end of every rainfall. This has led to the softening of the soil allowing it to be easily washed off by runoff water.

The type of erosion occurring in this area is gully erosion. This type of erosion can be controlled firstly by tracing the runoff sources and reducing the speed through planting vegetative covers which will help reduce the velocity of the runoff that is passing through this channel. It can also be controlled by the use of Gabions, the gabions are made of a porous structure that is made of heavy duty wire netting that is filled with stones which will make for easy passage of water and allow sediment concentration that will help the area to recover its lost soil. Terraces can also help in controlling the amount of runoff that goes into the by diverting the runoff into other channels.

Finally, laws should also be enacted to control the human activities that contribute to the erosion problem.

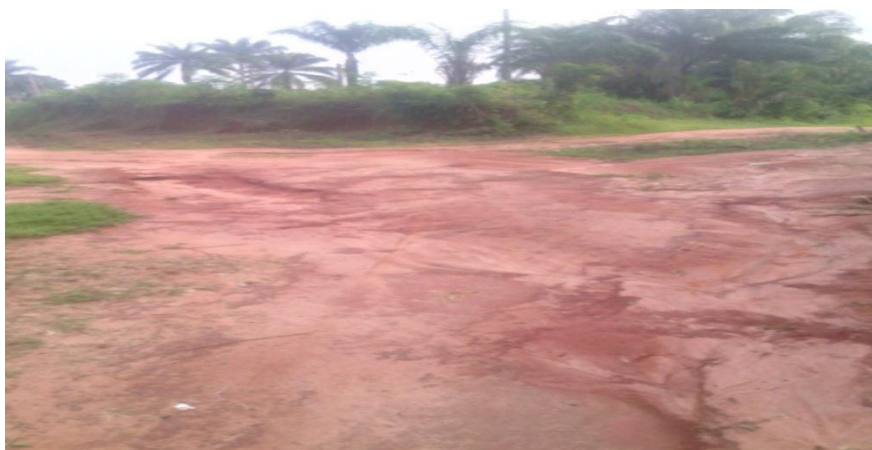
Plate 4: Erosion at site D

Table 4: Observation at site D

Month	Length (m)		Width (m)		Depth (m)		Nature (m)
	X	Y	X	Y	X	Y	
March	29.65	29.83	0.86	0.92	0.14	0.18	Rill
April	29.83	30.9	0.92	1.24	0.18	0.22	Rill
May	32.32	34.0	1.28	1.36	0.24	0.29	Rill

This area is sloppy in nature and is barred of vegetative covers and drainage passage, this makes it easy for raindrops and erosive water to move freely on the land surface with high velocity causing the soil to be detached and carried away. From residents response there was vegetative covers in this area before the road was graded.

The type of erosion occurring in this area is rill. This can be controlled by the following ways: Drainage ways should be constructed at both sides of the road, the runoff sources should be traced and the runoff water diverted into the constructed drainages by creating channels that will help carry the runoff water into the drainages or by laying underground pipes that will carry the water. This will reduce the amount of water that will flow down the slope without having effect on the soil. Secondly, vegetative covers should be planted; this will help absorb the impact of raindrops and runoff velocity on the soil surface by increasing infiltration rate.

Also, a semi-permeable synthetic ground cover(fabric) can be laid on the slope add stability, it will slow the water flow and allow it to be absorbed by the soil, as well as keeping the water from washing the soil away. Finally, the road should be graded and asphalted with drainage structures or ditches constructed at both sides of the road this will eradicate the erosion at this site for a long period of time.

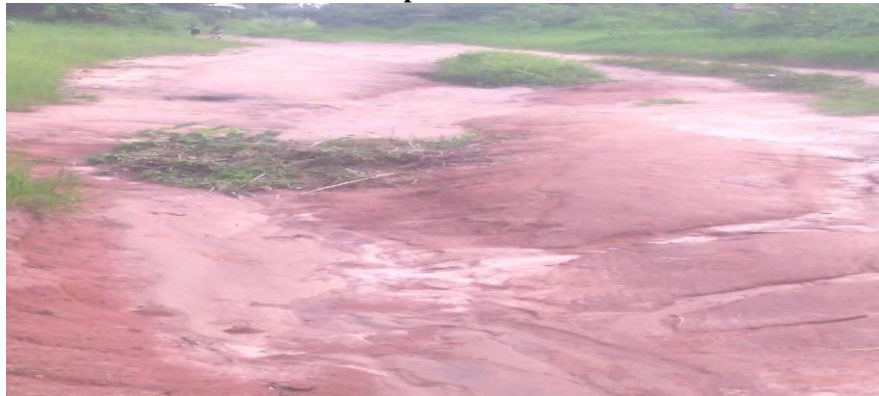
Plate 5: Erosion at site E

Table 5: Observation at site E

Month	Length (m)		Width (m)		Depth (m)		Nature (m)
	X	Y	X	Y	X	Y	
March	29.45	30.9	1.35	1.43	0.21	0.27	Rill
April	30.9	32.0	1.35	1.43	0.27	0.33	Gully
May	33.0	34.0	1.48	2.02	0.37	0.43	Gully

From the plate 5 it can be observed that the rate of runoff flow is too high in this area and the land is barred of vegetative covers that will reduce the speed of the runoff thereby causing it break and carry away the soil particles easily. Responses from the residents showed that the removal of drainage channels that were in this area due to construction led to the occurrence of erosion.

The type of erosion occurring in this site is gully. To get this area under control, the sources of erosion should be tackled first. These sources can be tackled by reducing the runoff speed so that the rate of erosion occurring at site E will be reduced. The runoff sources can be reduced by planting grasses and trees that can thrive in the environment. Channels should be created by the sides of the road to divert the excess runoff that the adjacent side of the road. The eroded portions should be mulched before grading or filled with stones to enable it trap sediments and reduce the rate of scouring and soil loss.

If the road can be graded and asphalted with drainage channels at both sides of the road, it will be the best solution in solving the erosion menace at this site.

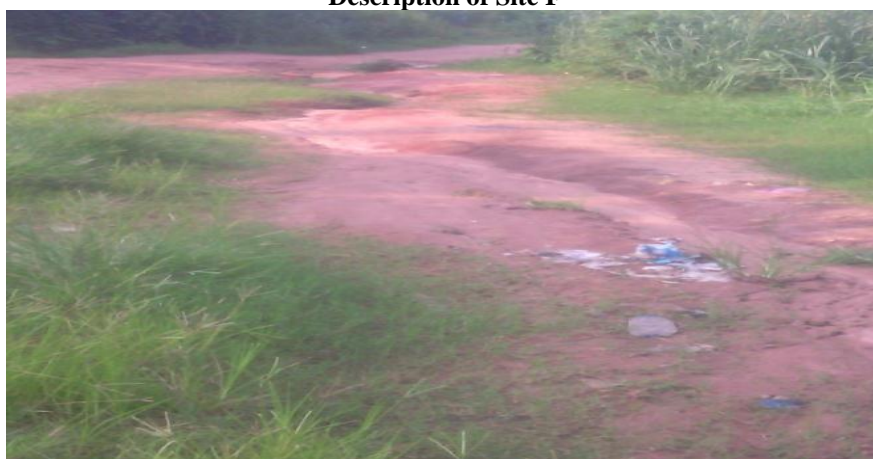
Plate 6: Erosion at site F

Table 6: Observation at site F

Month	Length (m)		Width (m)		Depth (m)		Nature (m)
	X	Y	X	Y	X	Y	
March	27.56	28.70	1.27	1.38	0.22	0.26	Rill
April	28.70	29.82	1.38	1.43	0.26	0.29	Rill
May	31.64	33.56	1.69	1.93	0.32	0.34	Gully

The land management practice in this area is very poor as the drainage channels has been covered with sediments and bushes there by, causing runoff water to flow through the road and cause erosion since the soil in the area is no longer compactable to accommodate the flow without been washed away.

The type of erosion occurring in this area is gully. This type of erosion can be reduced by first clearing the drainage channels so that runoff water can flow freely without been obstructed. Terraces can also be built to divert excess runoff away from the road.

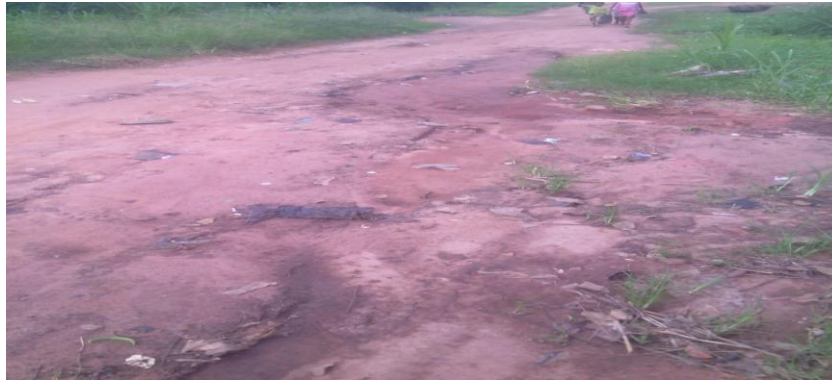
Plate 7: Erosion at site G

Table 7: Observation at site G

Month	Length (m)		Width (m)		Depth (m)		Nature (m)
	X	Y	X	Y	X	Y	
March	26.78	27.02	1.35	1.38	0.16	0.23	Rill
April	27.02	27.54	1.38	1.45	0.23	0.26	Rill
May	28.03	28.67	1.50	1.86	0.26	0.29	Rill

The rate of rainfall in this area is very high and the area lacks drainage control channels which make it easy for erosive water to be passing through the road causing the soils to be easily detached and carried away. The resident in this area observed that the erosion started occurring due to the removal of drainage channels and abandonment after grading the area for construction.

Drainage channels should be created at both sides of the road, the road should also be graded and vegetative covers that thrive in the area should be planted too to help reduce raindrop impact and runoff speed.
