ANALIZA UZROKA POJAVE OTKAZA SUS MOTORA I PREDLOG ZA NJEGOVO OTKLANJANJE

Na motoru Caterpillar USA tip 3126, sa brojem BEJ12686, radne zapremine 7200 cm³ i snage 168 kW (slika 1), koji je ugrađen u drobilicu za drvo proizvođača Vermeer Mfg. Company, tip BE 2000XL sa identifikacionom oznakom 1VRZ1S20171000278 (slika 2), došlo je do pojave otkaza. Usledio je pokušaj otklanjanja tog otkaza. Po završetku svih sprovedenih postupaka održavanja koji su imali za cilj vraćanje motora u ispravno stanje, došlo je vrlo brzo do ponovne pojave otkaza, i to na isti način.

ANALYSIS OF THE CAUSES OF IC ENGINE FAILURE AND PROPOSAL FOR ITS REMOVAL

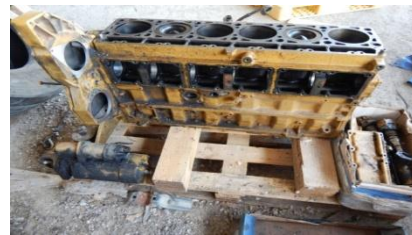
- Drobilica za drvo proizvođača "Vermeer Mfg. Company" tipa BE 2000XL, pre ove analize radila je 1093 časova;
- Na bloku motora nema vidnih oštećenja;
- Oštećena je bregasta osovinica na mestu šetog izduvnog ventila (slike: 5, 6);
- Pohabane su, i postoji veliki zazor između klackalice i njenog rukavca šestog izduvnog ventila koji je doveo do mogućnosti aksijalnog pomeranja klackalice (slike: 11,12);
- Oštećene su dodirne površine nosećeg dela "klackalica" i "glave" motora na delu klackalice ventila šestog cilindra (slike: 8,9,10);
- Oštećeni zu prateći delovi razvodnog mehanizma: nosač rolnice podizača šipke izduvnog ventila na šestom cilindru polomljen (slika 16), rolnica podizača šipke izduvnog ventila na šestom cilindru ispala i oštećena (slika 15), osovinica rolnice podizača šipke izduvnog ventila na šestom cilindru ispala i oštećena (slika 16);

Slika 4. Blok pogonskog motora proizvodnje Caterpillar tip 3126 - pogled sa boka
Figure 4. Caterpillar production engine block - side view

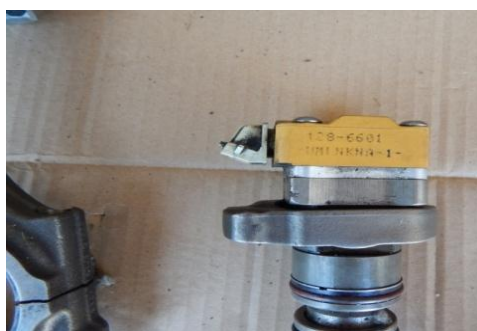
Slika 23. Brizgač - injektor šestog cilindra motora drobilice za drvo

Figure 23. Injector - injector of the sixth cylinder of the crusher engine for wood
